**DEPARTMENT OF TRANSPORTATION**

Contract #: 04-0120F4Cty: SF/ALA Rte: 80 PM: 13.2/13.9File #: 1.28**WELDING INSPECTION REPORT****Resident Engineer:** Casey, William**Address:** 333 Burma Road**City:** Oakland, CA 94607**Report No:** WIR-028228**Date Inspected:** 24-Aug-2012**Project Name:** SAS Superstructure**OSM Arrival Time:** 1100**Prime Contractor:** American Bridge/Fluor Enterprises, a JV**OSM Departure Time:** 1930**Contractor:** American Bridge/Fluor Enterprises, a JV**Location:** Job Site**CWI Name:** As noted below.**CWI Present:** Yes No**Inspected CWI report:** Yes No N/A**Rod Oven in Use:** Yes No N/A**Electrode to specification:** Yes No N/A**Weld Procedures Followed:** Yes No N/A**Qualified Welders:** Yes No N/A**Verified Joint Fit-up:** Yes No N/A**Approved Drawings:** Yes No N/A**Approved WPS:** Yes No N/A**Delayed / Cancelled:** Yes No N/A**Bridge No:** 34-0006**Component:** Tower**Summary of Items Observed:**

# WELDING INSPECTION REPORT

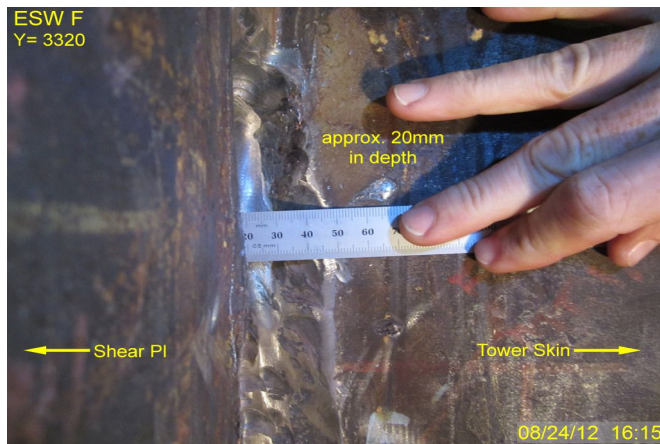
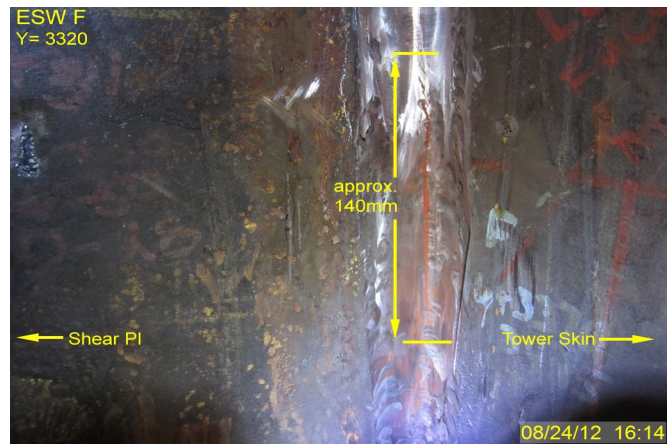
This QA observed ABF/JV welding personnel James Zhang #6001 performing excavation of an Electroslag Weld (ESW) repair previously Magnetic Particle Tested (MT) by Quality Control (QC) technicians.

The MT discovered indication was found to be oriented in the longitudinal position along the toe of the repair weld.

The weld being excavated is designated as "ESW F" and was excavated on Face B at location:  
Weld "F" – Y= 3320mm.

The carbon arc gouging process, as well as machine grinding, are being used to excavate this weld. At random intervals both QA and QC performed Magnetic Particle Testing (MT) to determine if the rejectable indication had

been removed.

This excavation is in-process and final measurements have not been taken.
